## **August 31, 2006 Embankment Failure – Debris Flow at the Cascades Development Haywood County, North Carolina**

### **Introduction**

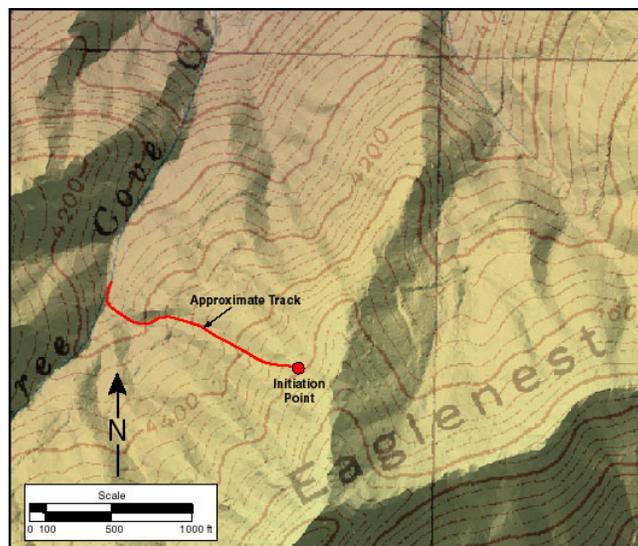
The debris flow appears to have initiated as an embankment failure at the southwest termination of a development road at elevation ~4580 ft. (latitude 35.49239 degrees; longitude -83.07519 degrees) on the northwest-facing slopes of Eaglenest Ridge (Figures 1 and 2). This location is about 2 miles southeast of Maggie Valley. The track is about 90 feet wide at the widest point and is about 1,300 feet long (Figures 2 and 3). The upper portion of the track is scoured down to bedrock, and most of the mud, boulders and large woody debris of the deposit came to rest in the lower 500 feet of the track. The lower 200 feet of the track is in Pine Tree Cove Creek. A large volume of material transported by the debris flow was deposited in lot 107 (Figure 4). Had there been a home on this lot it would have been significantly damaged, if not destroyed, by a direct hit from a debris flow of this magnitude.

**Figure 2.** Excerpt of topographic map showing the initiation point and approximate track of the August 31, 2006 embankment failure-debris flow. The base map is a hillshade derived from a LiDAR (Light Detecting And Ranging) digital elevation model. Contour lines are from the Hazelwood 7.5-minute topographic map.

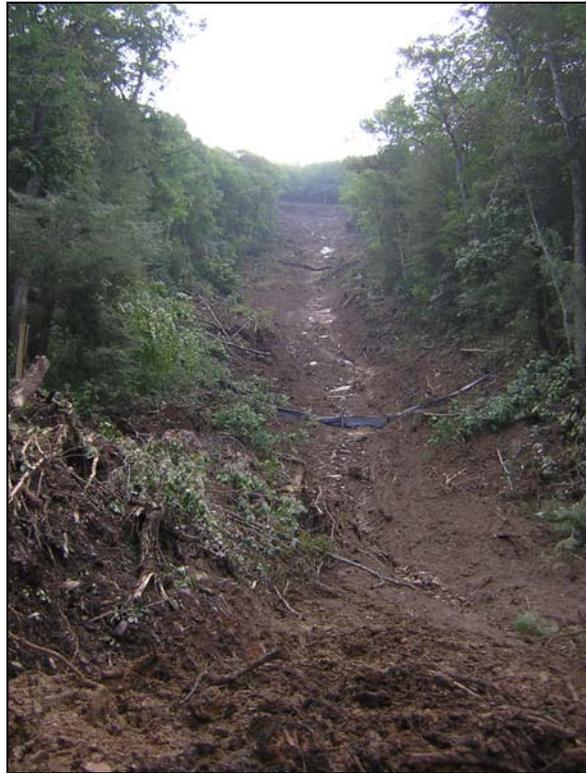
**Figure 3.** View looking up the track of the August 31, 2006 embankment failure-debris flow from the development road near lot 107. September 8, 2006 photograph.

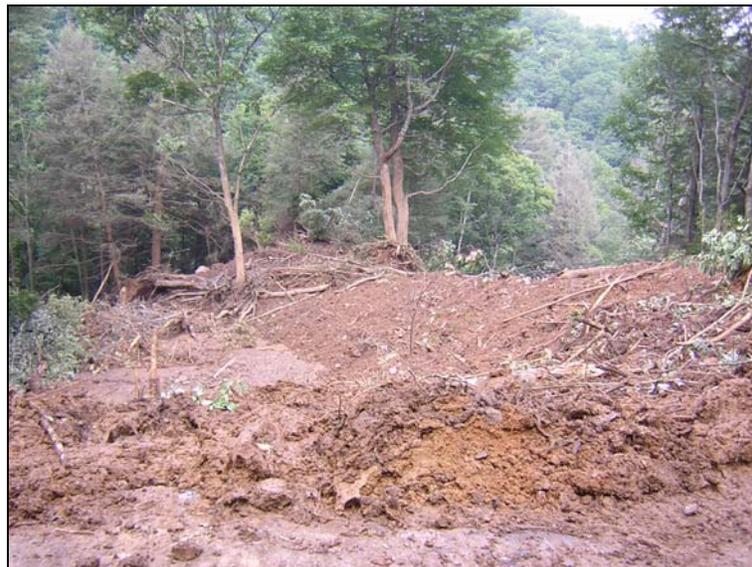
**Figure 4.** View looking downslope at the debris deposit and damage to lot 107. September 8, 2006 photograph.

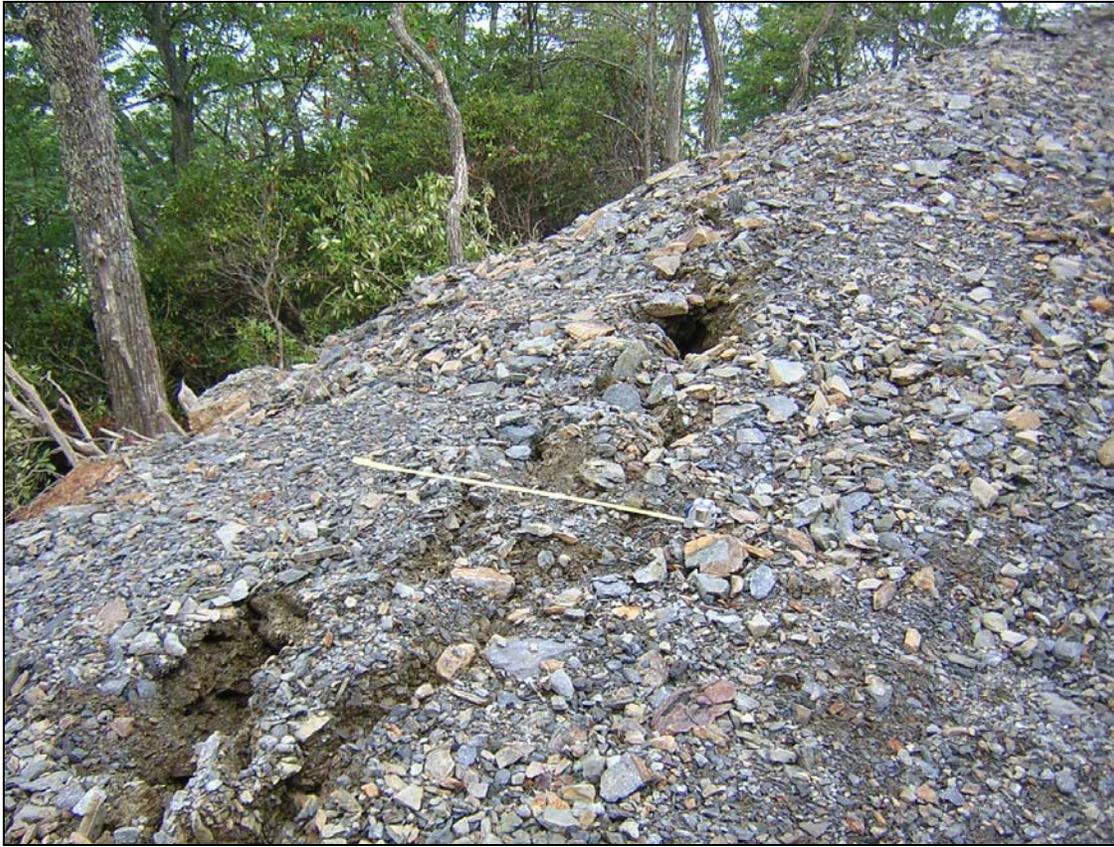
The remaining ~300-ft long extent of road embankment northeast of the head scarp of the August 31, 2006 failure is a primary concern for future embankment failures of similar magnitude. Future slope failures that pose a threat to public safety will likely originate in this embankment unless it is stabilized. Additional tension cracks observed in the embankment northeast from the scarp of the August 31, 2006 failure are evidence of other existing unstable areas (Figure 5). The embankment appears to be constructed with significant amounts of graphitic-sulfidic bedrock excavated by blasting to construct the road prism. This type of bedrock contains carbon in the form of graphite, and naturally occurring sulfur-bearing minerals such as pyrite and pyrrhotite.

**Figure 5.** View of cracks in embankment extending northeast from the head scarp of the August 31, 2006 embankment failure-debris flow. September 8, 2006 photograph.

Geologic and geotechnical expertise should be retained to determine the extent of graphitic-sulfidic rock, and the potential for future slope failures and acid runoff in the development area. The known ~300-ft length of embankment constructed with the graphitic-sulfidic bedrock should be stabilized or removed. Possible stabilization methods include: reconstructing the embankment in compacted lifts treated with lime and limestone as shown in Byerly (1996); or encapsulating the acidic material in lime and limestone as shown in Schaeffer (1996). Both of these methods neutralize the acidic runoff and improve the stability of the embankment. Establishing vegetation on an
