**Chowan River Basin
North Carolina
Riparian Shoreline Assessment Report**

Comprehensive Coastal Inventory Program
Center for Coastal Resources Management
Virginia Institute of Marine Science, College of William and Mary
Gloucester Point, Virginia
May, 2006

**Chowan River Basin North Carolina
Riparian Shoreline Assessment Report**

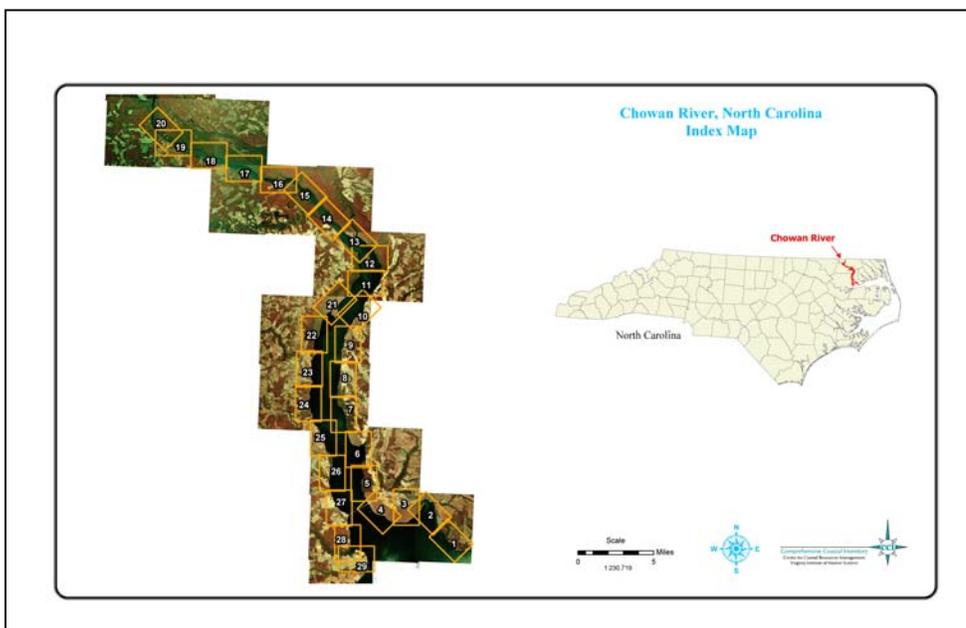
Figure 1. Map index for Chowan River

The home page summarizes the project and limitations associated with the data. From the page above, the user will find links to the report, maps, GIS data, photographs, and metadata. The link to “Maps” will take you to an index page illustrating the plate boundaries (Figure 1). This is useful if you are interested in a specific area. The index illustrates the distribution of plates geographically.

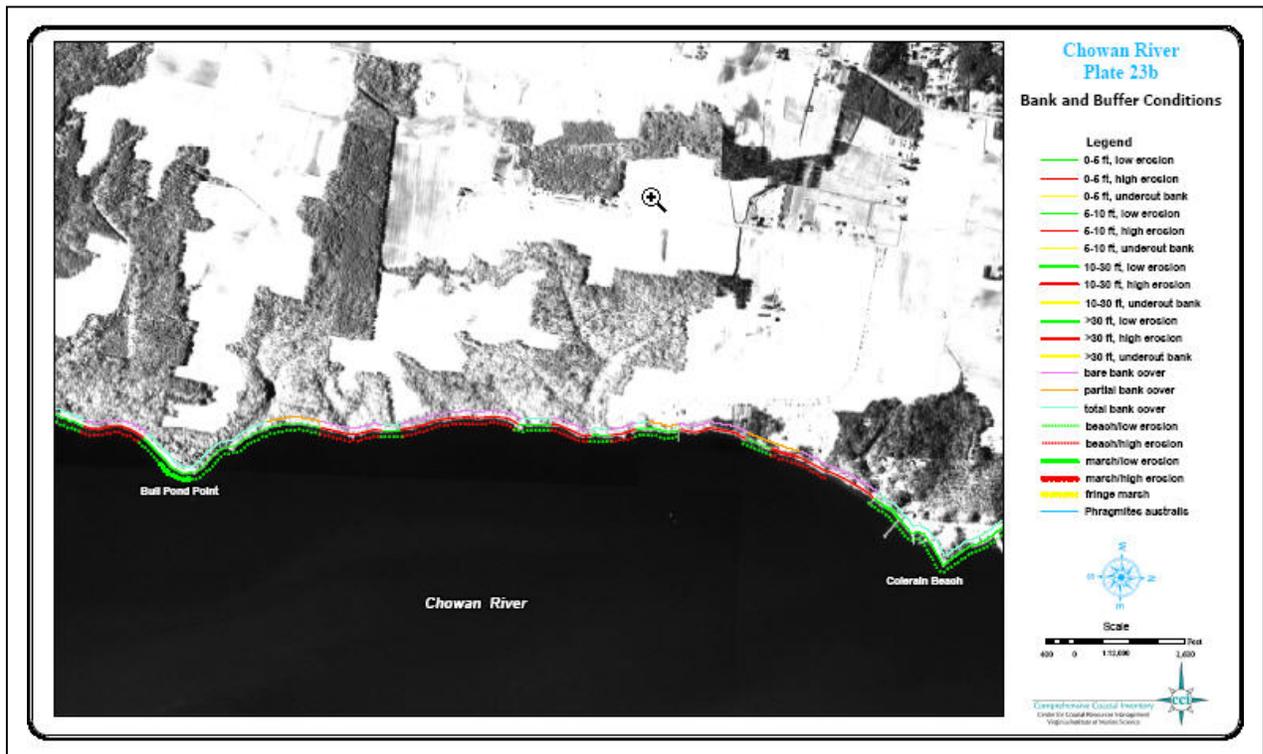
Figure 3. Sample riparian land use map for the Chowan River

three part plate series was described in detail in Chapter 2. The actual map will come up when you click on the plate number. For example, Figure 3 is the riparian land use map for plate 23. Figure 4 is the map illustrating Bank and Buffer conditions for plate 23, and Figure 5 shows all the shoreline features for that same area. You may open all three plates for the series, but can view only one at a time in most browsers. Tools for zooming and panning should be on the tool bar. The maps can be printed at full resolution up to 11x17 color. Color printers are necessary. Summary statistics for all data are reported in tables (see link).

Plate A describes the riparian land use as color-coded bars along the shore. A legend keys the color to the type of land use. If the dominant land use has maintained a tree line along

the bank, the line is hatched to denote a tree fringe. The background imagery is the color infra-red DOQQs at a publication scale of 1:12,000. Users should note that the imagery is sometime rotated in order to meet scale requirements and paper size. This means that “north” is not always to the top of the page.
