## Northeast Creek and Newport River Tributaries Site descriptions

*Prepared by NC Div. of Water Quality, Watershed Assessment Team  
May 22, 2008*

This information is provided as a supplement to the Northeast Creek and Newport Tributaries Summary of Special Study Results, May 22, 2008. For an overview of numerical results, please refer to that report. This document provides descriptions and photos of individual monitoring sites and conditions during sampling in January and March 2008 that may be helpful in interpreting those results.

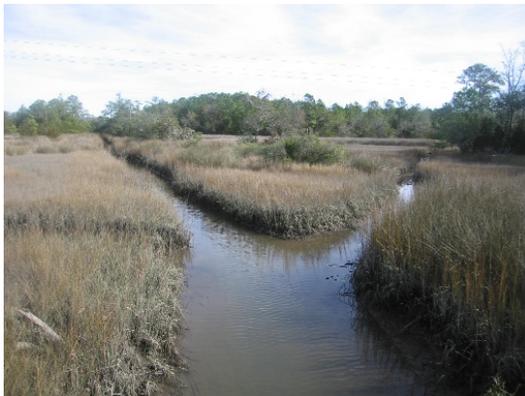
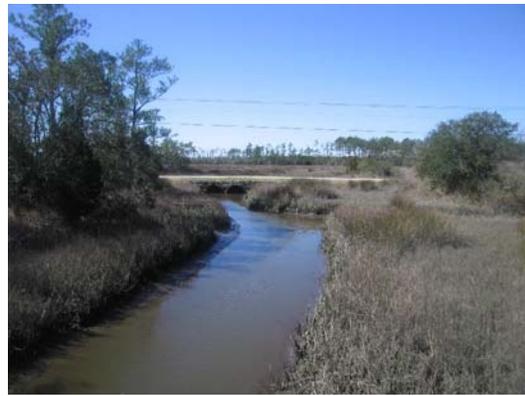
#### **NPT01: Eastman Creek at NC 101**

This appears to be a fairly typical stream surrounded by salt marsh. Conditions appeared similar during both sampling events, with samples being taken on an outgoing tide and an approximate maximum depth of 0.1 m. January sample may have been taken closer to ebb than the late winter samples in March.

Eastman Cr, upstream, Jan. 2008

Eastman Cr, downstream, Mar. 2008

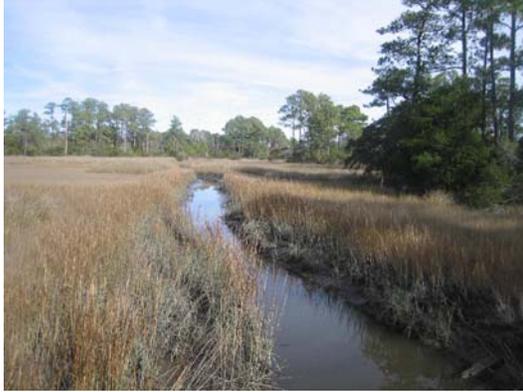
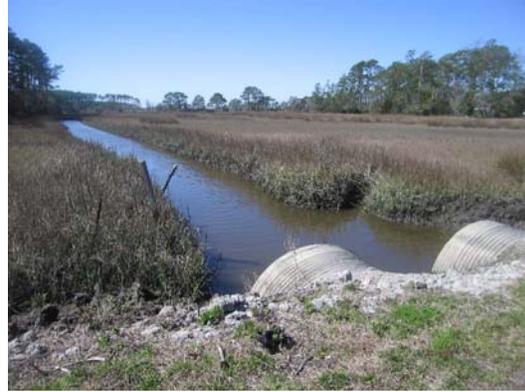
#### **NPT02: Bell Creek at NC 101**

Bell Creek seemed to be fairly similar to Eastman Creek, in that it appeared to be a typical tidal coastal stream surrounded by salt marsh. It appeared that the culvert had been recently replaced at the downstream road crossing. Conditions appeared similar during both sampling events, with samples being taken on an outgoing tide with an approximate maximum depth of 0.1 m. High turbidity was noted on both sampling visits.

Bell Cr, upstream, Jan. 2008

Bell Cr, downstream, Mar. 2008

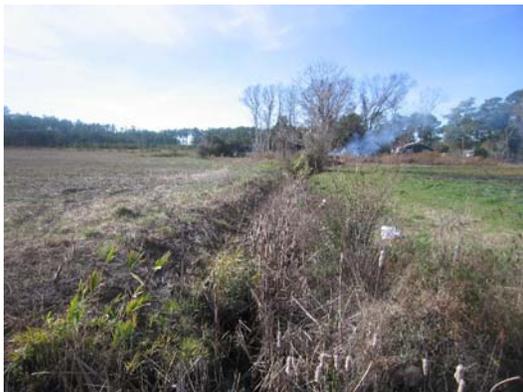
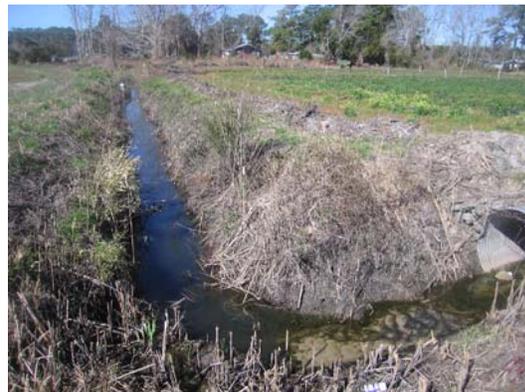
### **NPT03: N Ware Creek at NC 101**

This site, along with S Ware Creek, was distinctly different from the other Newport tributaries. N. Ware Cr. appears to be more of an agricultural ditch and drains active fields. It is connected to the roadside drainage ditches, and with no riparian buffers.

During the low flow sampling in January, there was no flow in the stream or roadside ditches. Heavy cattail growth was noted in the channel of N Ware Cr, and heavy filamentous algal growth was noted in the connected roadside ditches.

When re-sampled in March, it was obvious that the roadside ditches had been very recently cleared/dredged, with marks from the backhoe still very visible on the banks. It appears that some clearing of the creek itself had been done, as the thick cattail growth was no longer present. Though there was good flow (and numerous small fish) in the roadside ditches at this time, N Ware Cr itself was still stagnant and shallow (<0.1m). Extremely heavy filamentous algal growth was also present.

N Ware Cr, downstream, Jan. 2008

N Ware Cr, downstream, Mar. 2008

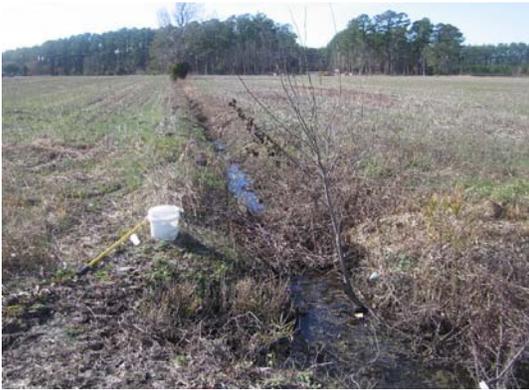
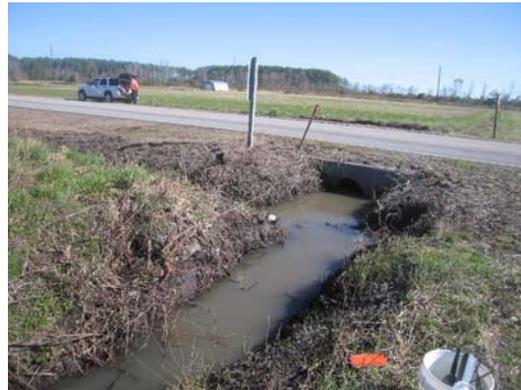
**NPT04: S Ware Creek at NC 101**

The conditions at S Ware Cr were nearly identical as those found at N Ware Cr, which is not surprising given their very close proximity. They both drain the same agricultural fields.

During the low flow sampling in January, there was no flow in the stream. This site lacked the heavy cattail growth noted at N Ware Cr, but still showed heavy filamentous algal growth. In March, only the roadside drainage ditches upstream of the road had been cleared. Some flow was noted in the channel proper upstream of the road, but it was stagnant downstream. Maximum width and depth were slightly greater than seen previously, though still <0.1m, and moderate amounts of filamentous algae were present.

S Ware Cr, downstream, Jan. 2008

S Ware Cr, below road, Mar. 2008

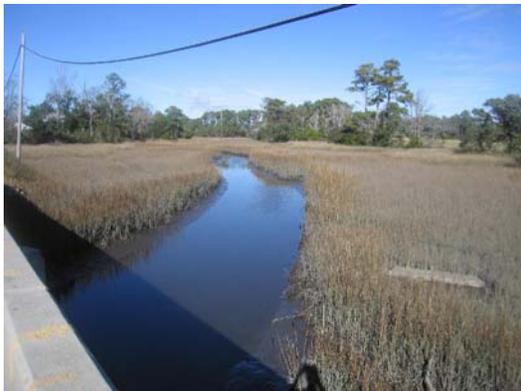
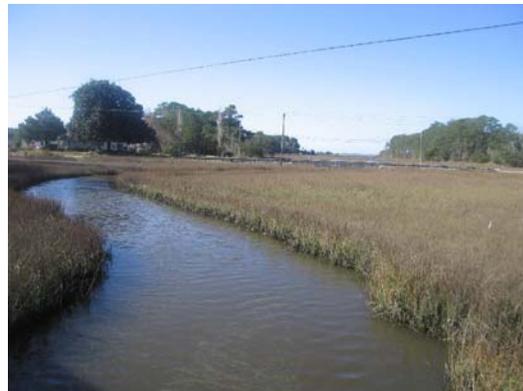
**NPT05: Russell Creek at NC 101**

Russell Creek was another typical tidal creek, similar to Eastman and Bell Creeks. Both sampling events occurred on an outgoing tide. The low flow sampling in January was taken at near ebb and the creek was very shallow with low velocity. The March sampling occurred sooner after flood, with higher flows and high turbidity noted, but maximum depth was only about 0.1m.

Russell Cr, upstream, Jan. 2008

Russell Cr, downstream, Mar. 2008

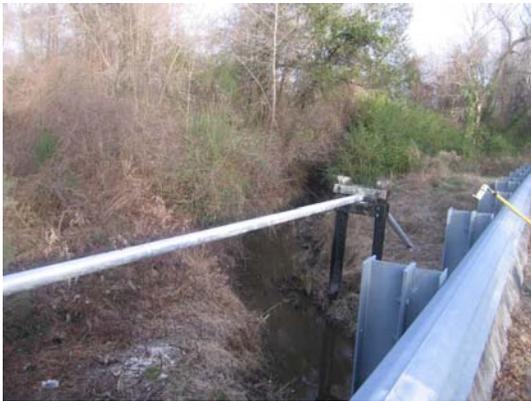
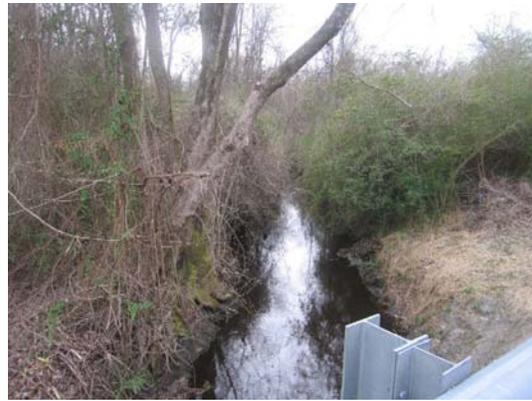
**NE01: Northeast Cr. at SR 1327**

Minimal flow was seen during the sampling visit. The stream is fairly narrow (~1.5m) and shallow. The channel is incised and water is very tannic. This site appears to be a dumping ground for road kill, as numerous relatively intact deer carcasses in varying states of decay were noted in the stream and along its banks. A small utility line crosses the stream above the road.

Northeast Cr at SR 1327, upstream, Jan. 2008

Northeast Cr at SR 1327, downstream, Mar. 2008

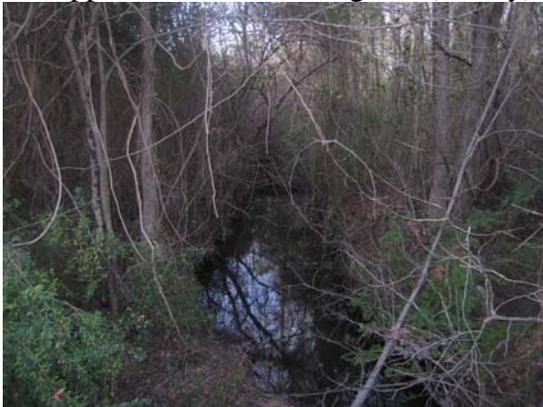
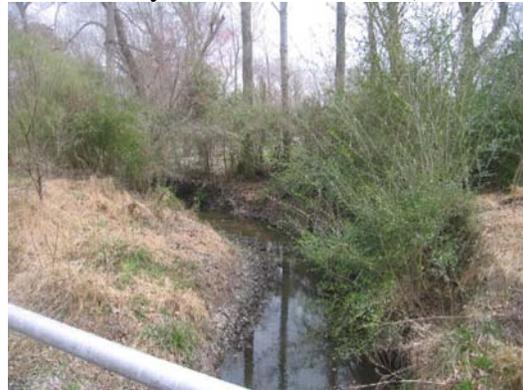
**NE02: UT to Northeast Cr.**

No flow was present in January, and only very slight flow was noted in March. Water was relatively clear and only slightly tannic. Stream was ~1.5m wide and shallow (0.15m). The substrate appeared to be more organic (mucky) than the nearby Northeast Cr. site (NE01).

UT to Northeast Cr at SR 1327, downstream, Jan. 2008

UT to Northeast Cr at SR 1327, upstream, Mar. 2008

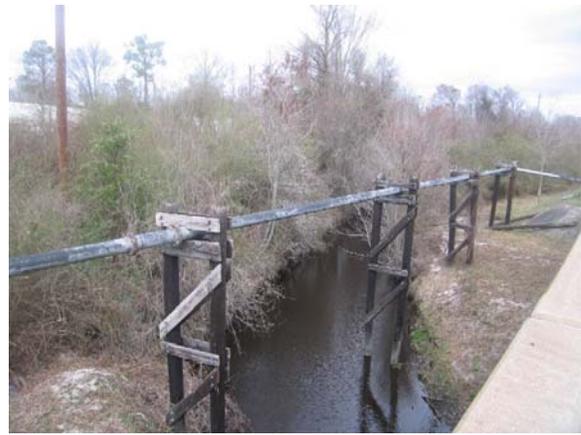
**NE03: Northeast Cr. at NC 17**

Conditions were fairly comparable during the two sampling visits. Low flows were noted, even when good flow was noted at the upstream site at SR 1327 (NE01). The creek was very tannic and about 5m wide with a maximum depth was about 0.4m. Banks were deeply incised and nearly 2m in height. Lots of periphyton and some filamentous green algae were present during the December reconnaissance visit though not noted during the January and March sampling visits. A trunk line crosses the stream.

Northeast Cr at NC 17, upstream, Mar. 2008

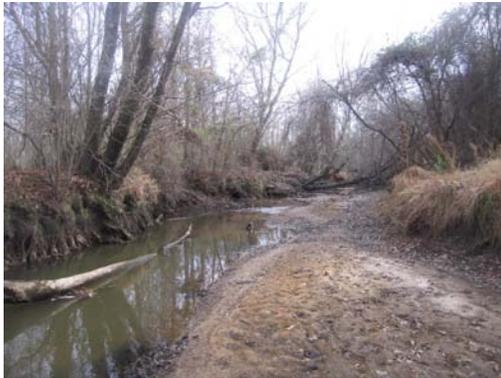
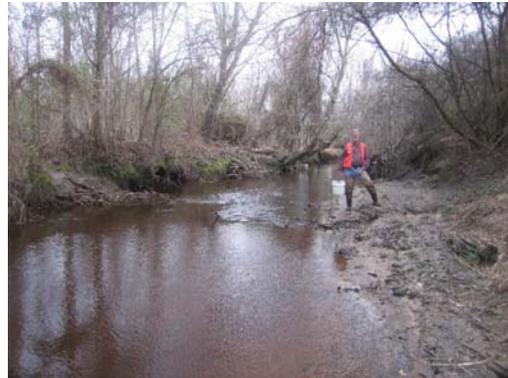
**NE04: Northeast Cr. below confluence with Wolf Swamp**

This site was accessed off the end of Thomas Humphrey Rd. (SR1409). As compared to other study sites, flow was generally good here, though stage appeared to be very low, particularly in January. The creek was about 4m wide and 0.5m deep during the March visit. Water was very tannic during the March visit.

Northeast Cr below Wolf Sw, downstream,  
Jan. 2008

Northeast Cr below Wolf Sw, downstream,  
Mar. 2008

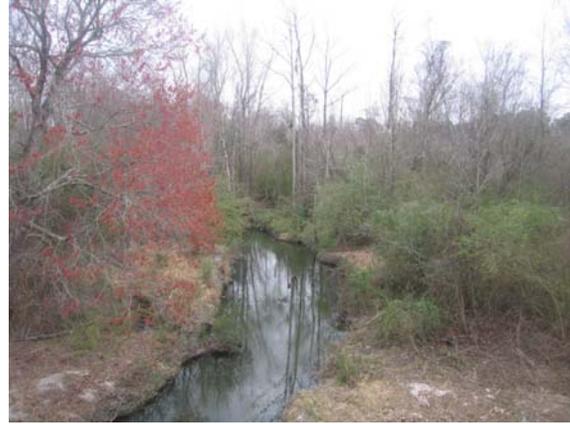
**NE05: Wolf Sw. at US 17**

The stream is fairly wide (4-5m) with an average depth of about 0.5m. The stream was not flowing at the time of sampling in January. Very slight flow may have been present at the March sampling, though it may have been merely wind-driven. However, good flow had been noted during initial watershed reconnaissance in December 2007.

Wolf Sw. at US 17, upstream, Mar. 2008

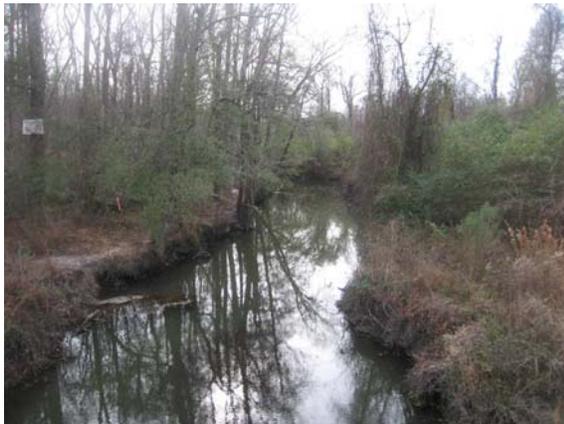
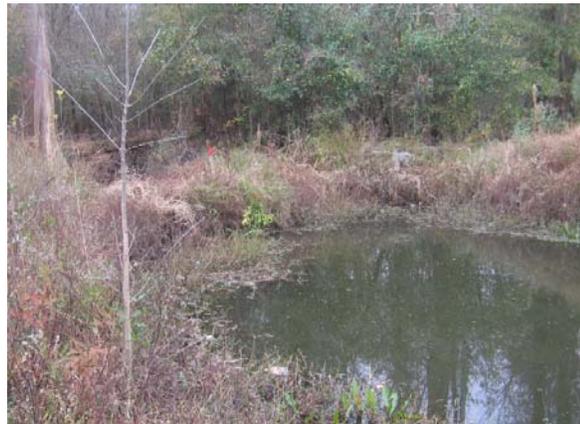
**NE06: Northeast Cr. at SR 1406**

The creek had a much sandier substrate than at upstream sites. There is a NPDES discharge (Regalwood WWTP) located upstream of this location. The creek was 4m wide but shallow (0.1-0.3m deep) during the January visit. Depth had increased to near 1m in March. The stream exhibited very slight flow during all sampling visits. It appears that a tributary (possibly an old ditch) had been impounded by a series of earthen dams. It appeared to be, possibly, a wetland restoration or creation project, though no record of such a project could be found in the DWQ Basin Information System (BIMS).

Northeast Cr. at SR 1406, downstream, Jan. 2008

Earthen impoundment at mouth of UT to Northeast Cr. (near site NE06), Dec 2007

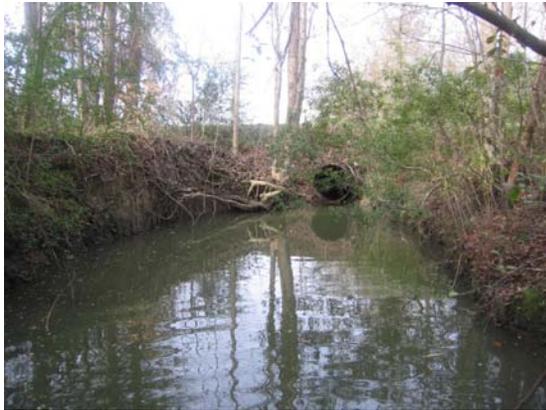
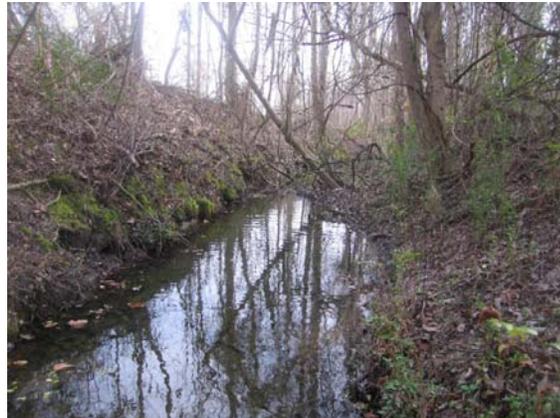
**NE07: Unnamed tributary to Poplar Cr. at SR 1411**

The reaches upstream and downstream of the road have no connection due to a severely perched culvert. The corrugated metal culvert is also showing severe corrosion and appears to be in poor condition. The downstream reach was sampled for this study, as the upstream reach was not deep enough to submerge a sample bottle. Below the road, the stream was ~2m wide with a substrate that appears to be a mix of sand, muck and clay.

During the January sampling, the water was visibly turbid with a green-blue color, indicating an algal bloom, and there was absolutely no flow; the stream was stagnant and ponded. It is likely

that a significant portion of the nutrients in the stream were actually tied up in the algae. This portion would not be represented in the analytical results from this study since water samples were filtered before analysis.

In March, flow conditions were still poor but water clarity had improved. A small trickle was coming from the culvert, though this was likely just groundwater infiltration as the upstream end of the culvert was still perched. Field notes indicate that there was significant coverage of the stream bottom by heavy periphyton and filamentous algae growth.

UT to Poplar Cr showing perched culvert and discolored water due to algae bloom, Jan. 2008

UT to Poplar Cr, downstream, Mar. 2008

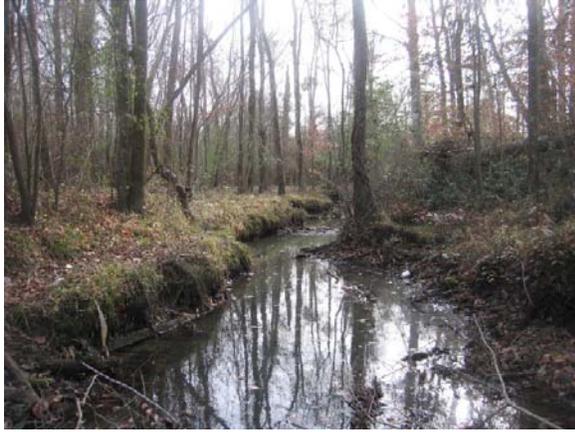
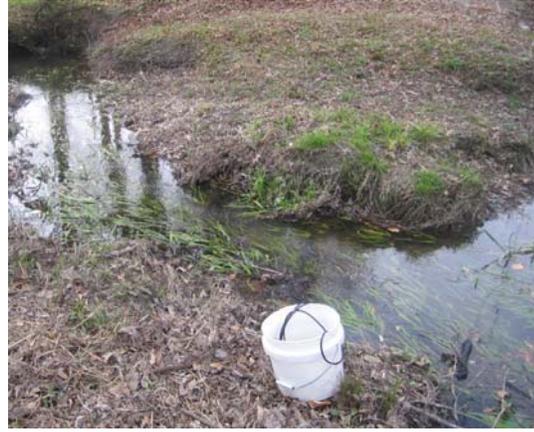
#### **NE08: Poplar Cr. at SR 1411**

A strong smell of horse manure was noted during all site visits, and a horse stable and pasture were located on one bank. A mix of manure and straw (likely sweepings from the stable) are apparently land applied by the stable owner along the road as well as the area between the pasture fence and the creek. It is likely that run-off from these applications enters the creek during rain events. The stream appeared unusual in that there was a significant amount of clay (marl) in the substrate and banks. It was 2.5m wide and 0.5m deep and there was no generally no or poor flow.

In January, no flow at all was noted. A bacterial oil sheen was present across much of the surface of the ponded creek. A dead deer was noted in the creek. Enrichment was indicated, as the roadside ditches that feed into the creek contained large, dry, brown-green mats of what appeared to be die-off from filamentous algal growth.

In March a short reach just below the road showed good flow, though quickly became stagnant about 10m downstream. Water clarity was excellent. A thick stand of what appeared to be *Sparganium* spp. was present in this flowing reach.

Poplar Cr, downstream, Jan. 2008

Poplar Cr, SAV bed, Mar. 2008

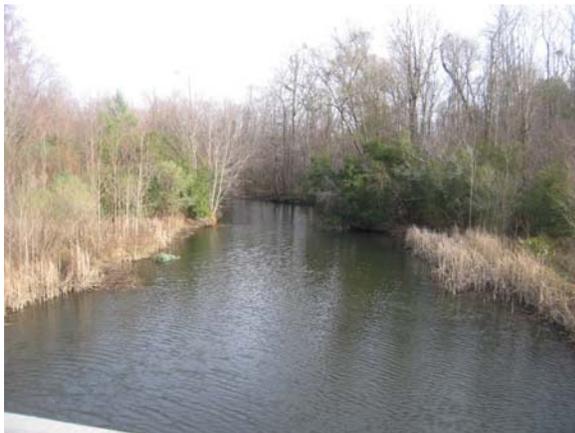
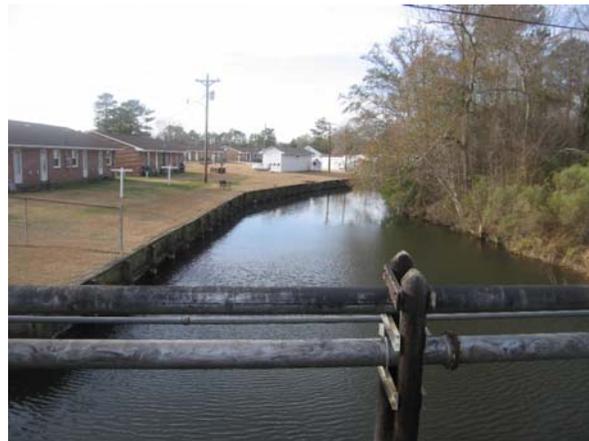
**NE09: Little Northeast Cr. at SR 1406**

The stream is 7-8m wide, tidal and likely brackish, suggested by the presence of crab pots at this location, though all salinity readings at this site were well below 0.5 ppt. Land use in the upstream portion is fairly undisturbed, but downstream of the road the entire left bank is bulkheaded, an apartment complex is present, and grassed yards extend completely to the bulkhead. Additionally, there are two minor NPDES discharges upstream of SR 1406 and two more downstream; impacts from all of these sites are likely due to the tidal influence here. During January sampling, flow direction could not be positively determined due to the wind, though it appeared to be near flood/high tide. In March, no flow was noted and the creek appeared to be at flood.

L Northeast Cr, upstream, Jan. 2008

L Northeast Cr., downstream, Jan. 2008

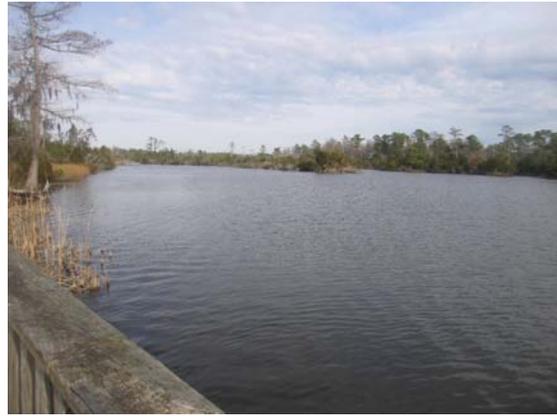
**NE10: Confluence of Northeast Cr. and L. Northeast Cr.**

Though it was initially intended that this site be accessed via boat, time and logistical constraints required that this location be accessed by land via a dock at the Northeast Creek Park. Though all of Northeast Cr. from its source to NC 24 carry the stream classification of “SC”, this was the most upstream brackish/salt site sampled. This location is tidal. There is also a NPDES discharge approximately 0.5 miles upstream on Northeast Cr.

Confluence of Northeast Cr. and L. Northeast Cr.,  
Jan. 2008

During the January sampling, the tide was coming in. There was a likely algal bloom, based on high pH and DO readings. Samples were difficult to filter, as the filters became quickly clogged, attributable to high algal density. As with the UT to Poplar site, nutrient results from this site may not truly represent total nitrogen and total phosphorus levels as nutrients may be tied up in the algal biomass.

In March, the bloom indicators were not seen. Samples were taken near high tide/flood, though salinity was much lower (8.2 ppt) than during the January sample (16.8 ppt).

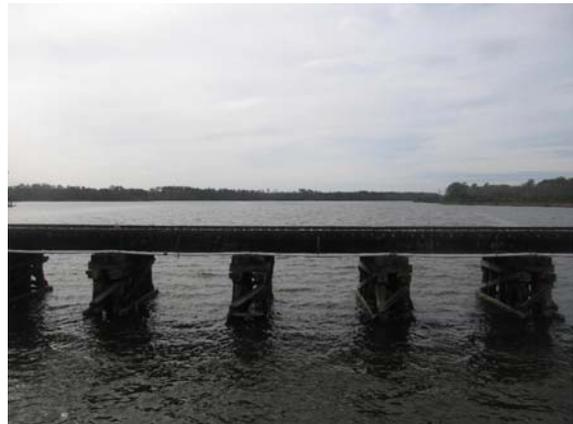
**NE11: Northeast Cr. at NC 24**

The creek is very large and tidal at this location. In January, the same indicators of an algal bloom seen upstream at NE10 were also noted here. Samples were collected on an incoming tide. In March, samples were collected near high tide/flood, and field indicators of an algal bloom were not present.

Northeast Cr. at NC 24, Jan. 2008
