Assessment Report: Biological Impairment in the Corpening Creek Watershed

Catawba River Basin
McDowell County

February 2004

North Carolina Department of Environment and Natural Resources
Division of Water Quality
Planning Branch

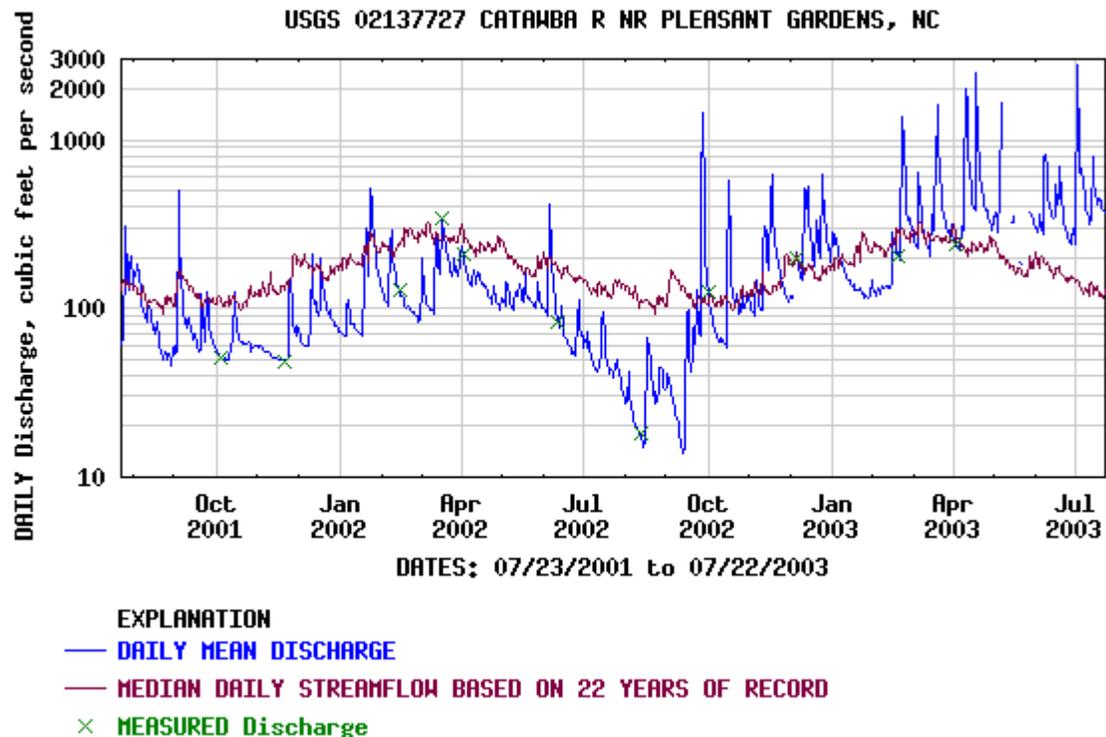
Figure 2.1

Corpening Creek probably followed a similar pattern. As shown in Figure 2.1, from July 2001 to July 2003 the Catawba River experienced a period of below average flow until October 2002. By March 2003, however, more rain fell and the flows were well above average. This is helpful to this study because it allows us to observe the stream during a range of conditions, when different causes and sources may be more prevalent.

Notes on Figure 2.1:

- 7Q10 listed as 48 cfs (1982-1988)
- For readers without a color printout, the median daily streamflow based on 22 years of record is the less dynamic line.

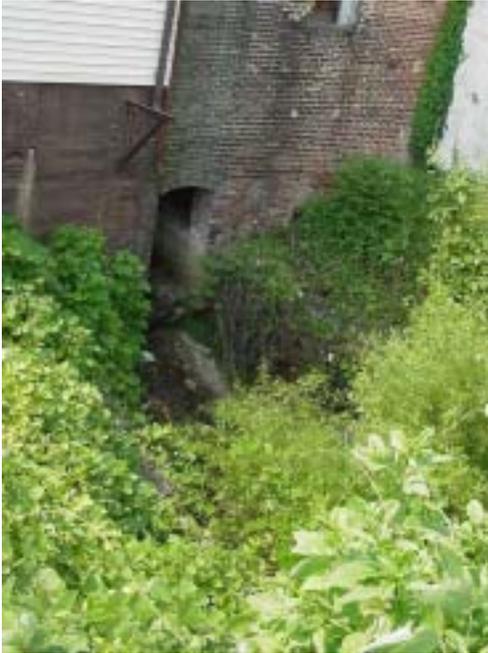
The headwaters of Corpening Creek flow under pavement and suddenly appear beneath a barbershop in Marion (Figure 2.2). From here the stream follows a fairly straight path through a kudzu-covered ravine to a more residential section (Claremont St. and Currier St.) of town.

Figure 2.2 Corpening Creek headwaters emanating from below a barber shop in downtown Marion.

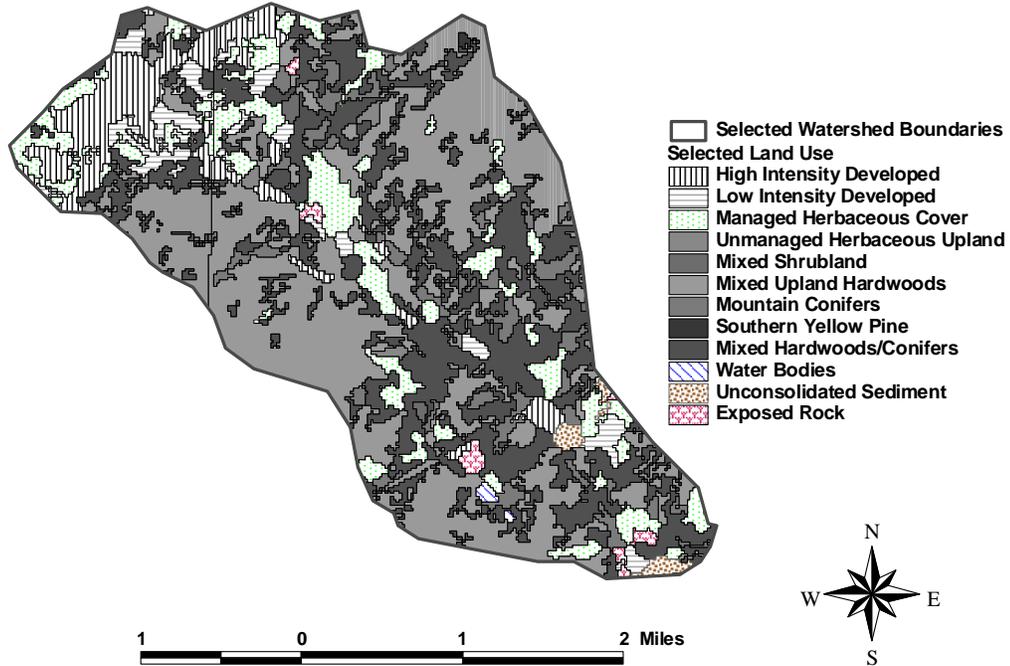
The distribution of land cover in the watershed is shown in Figure 2.3 and Table 2.1. The land use/land cover characteristics of the watershed were determined using 1996 land cover data that were developed from 1993-1994 LANDSAT satellite imagery. The North Carolina Center for Geographic Information and Analysis, in cooperation with the N.C. Department of Transportation and the United States Environmental Protection Agency Region IV Wetlands Division, contracted Earth Satellite Corporation of Rockville, Maryland to generate comprehensive land cover data for the entire state of North Carolina. During the formation of this dataset, developed land was identified using the proportion of synthetic cover present; low density developed was 50-80% synthetic cover, and high density developed was 80-100% synthetic cover. Assuming that synthetic cover is impervious, and that all non-developed land cover classes have 1% impervious cover, the Corpening Creek watershed is estimated to have 12% impervious cover. This estimate is probably low, however, as subsequent development has certainly occurred since 1993-1994. Also, this dataset is known to underestimate urban land cover as trees can partially cover smaller patches of synthetic cover. Thus, considering all the factors, the impervious cover today is likely to be **at least 15%**.

Corpening Creek Watershed Land Use

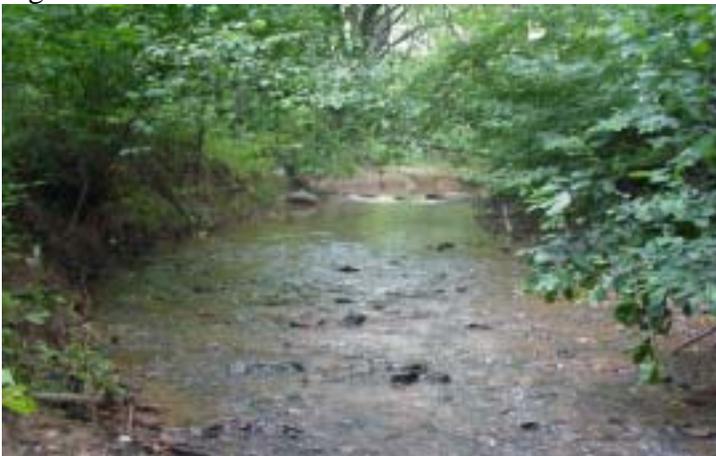
The reference stream, Jacktown Creek, seems to have similar habitat to the Corpening Creek study sites. Its more diverse and less stressed benthic community may be attributable to less urbanized land use (essentially no commercial or industrial sites) in the catchment.

Figure 4.1 Jacktown Creek above NC-226.

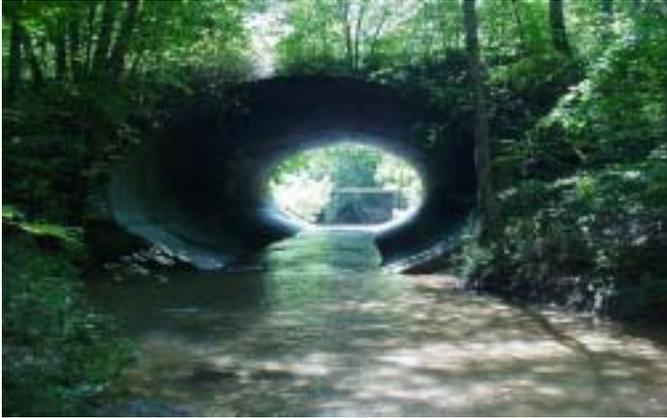
Figure 4.2 Looking down Corpening Creek below College Rd. (SR1819)

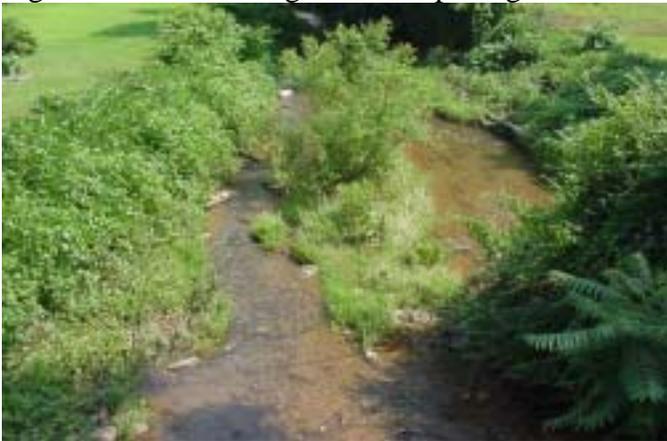
Figure 4.3 Looking down Corpening Creek from Jacktown Rd.

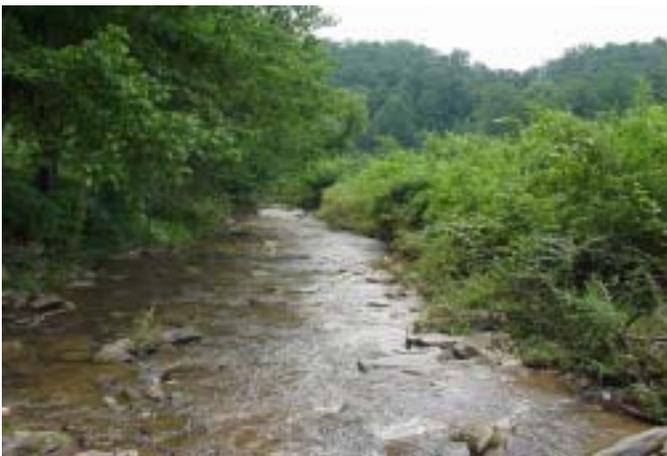
Figure 4.4 Looking down Corpening Creek toward Youngs Fork Rd.

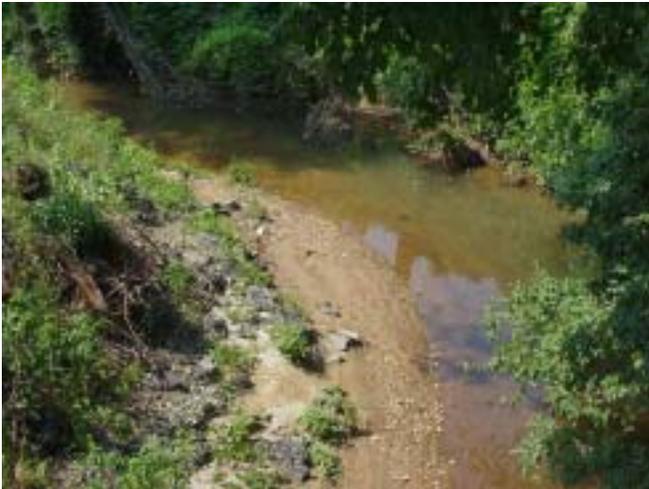
Figure 6.2 Looking up Corpening Creek from Jacktown Rd. Stream has significant sedimentation.

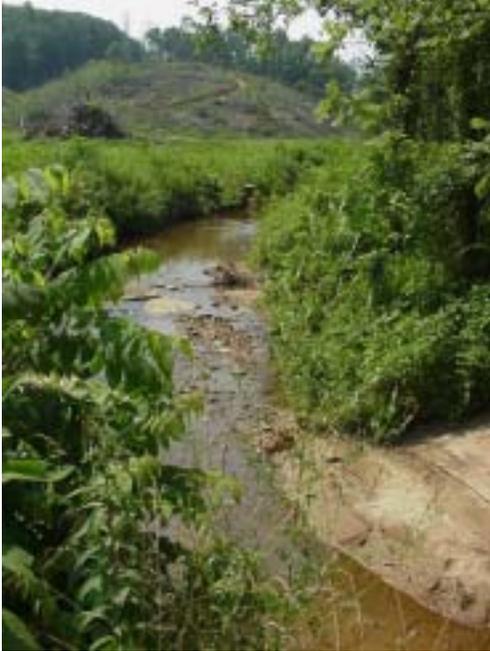
Figure 6.3 Looking up Corpening Creek from Youngs Fork Rd. Sedimentation is significant, and riparian buffer recently cut. Riffles still have good coverage of cobbles.

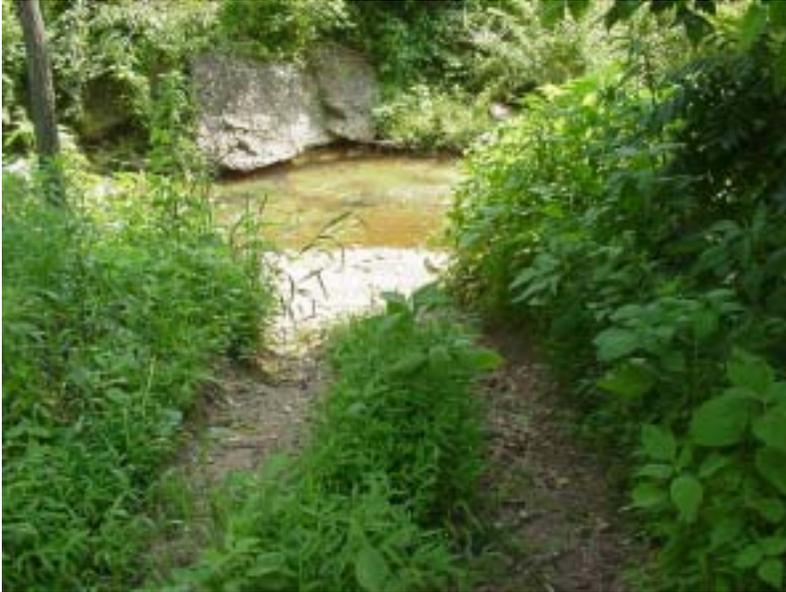
the watershed. This destabilizes streambanks and damages in-stream habitat. See Figure 8.1.

Figure 8.1 ATV tracks down streambank, into the stream channel (just upstream from Youngs Fork Rd.).

Stream channel restoration involves re-establishing a stable channel dimension (cross-section), pattern (sinuosity and planform) and longitudinal profile. While other options exist (see NCSU, 2001 and 2002), the most feasible approach to the restoration of most channels in this watershed is probably to construct appropriate floodplain area and channel form within the existing incised channel (Rosgen priority 2 or priority 3 approach). The specific restoration strategy selected will depend on the stream corridor width available (belt width), among other factors (NSCU, 2001 and 2002; Rosgen, 1997). Based on the recent experience of the North Carolina Wetlands Restoration Program (Haupt et al., 2002) and a number of Maryland counties that have active restoration programs (Weinkam et al., 2001), cost of at least \$200 per linear foot (about \$1 million per mile) should be expected for the restoration of urban stream channels.

Riparian areas are poorly vegetated along much of Corpening Creek. Reestablishment of woody riparian vegetation is probably necessary to ensure an adequate supply of woody material to the stream channel. In addition, properly functioning riparian areas can also serve to reduce inputs of nutrients and other pollutants.

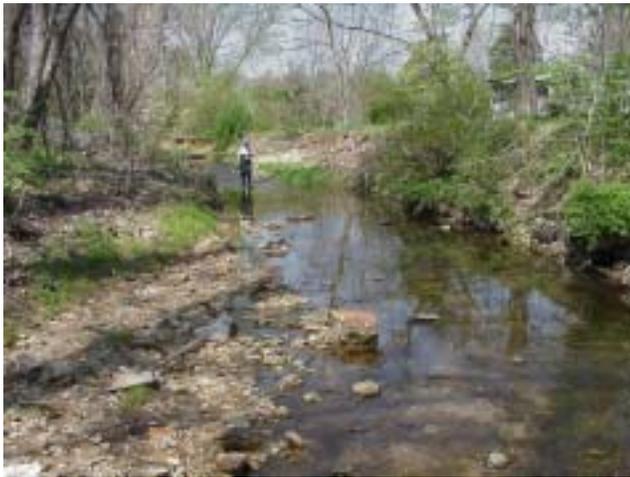
Young Fork Creek off US 226 near Claremont St.

Youngs Fork Creek off US 226, 2 blocks downstream of Claremont St. in Marion, McDowell County, Catawba subbasin 30, 4/09/01. This site was very near the headwaters, near an industrial/commercial area near Broyhill Industries.

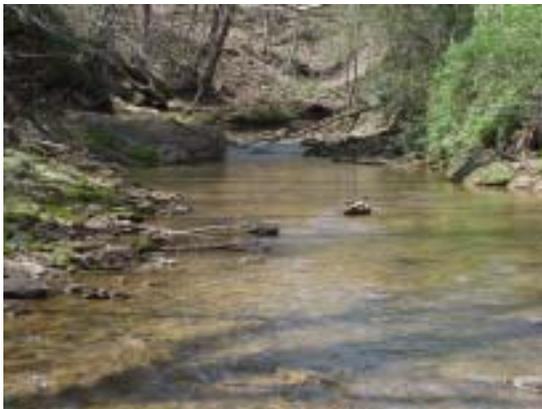
Youngs Fork Creek SR 1819

Youngs Fork Creek SR 1819, McDowell County, CTB 30, 4/9/01. This site, upstream of the WWTP has been sampled 3 times previously.

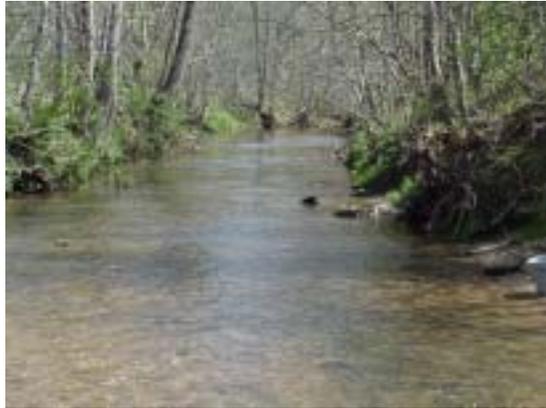
Youngs Fork Cr SR 1794

Youngs Fork Creek SR 1794, McDowell County, CTB 30, 4/9/01. This site, downstream of the WWTP, has been sampled twice previously.

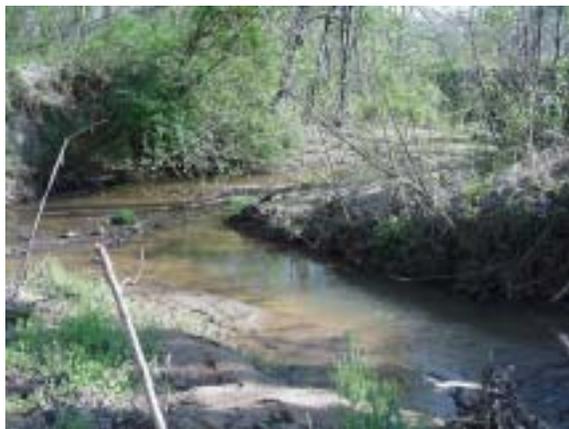
Jacktown Creek US 226

Jacktown Creek US 226, McDowell County, CTB 30, 4/9/01. This site was chosen as a reference, similar in character, with a more normal conductivity reading for the area. Staff from the ISU recorded higher conductivity values from all sites on Youngs Fork Creek than measured from other drainages in the area during the initial survey in October.
