# Assessment Report: Biological Impairment in the Burnt Mill Creek Watershed

Cape Fear River Basin  
New Hanover County

February 2004

North Carolina Department of Environment and Natural Resources  
Division of Water Quality  
Planning Branch

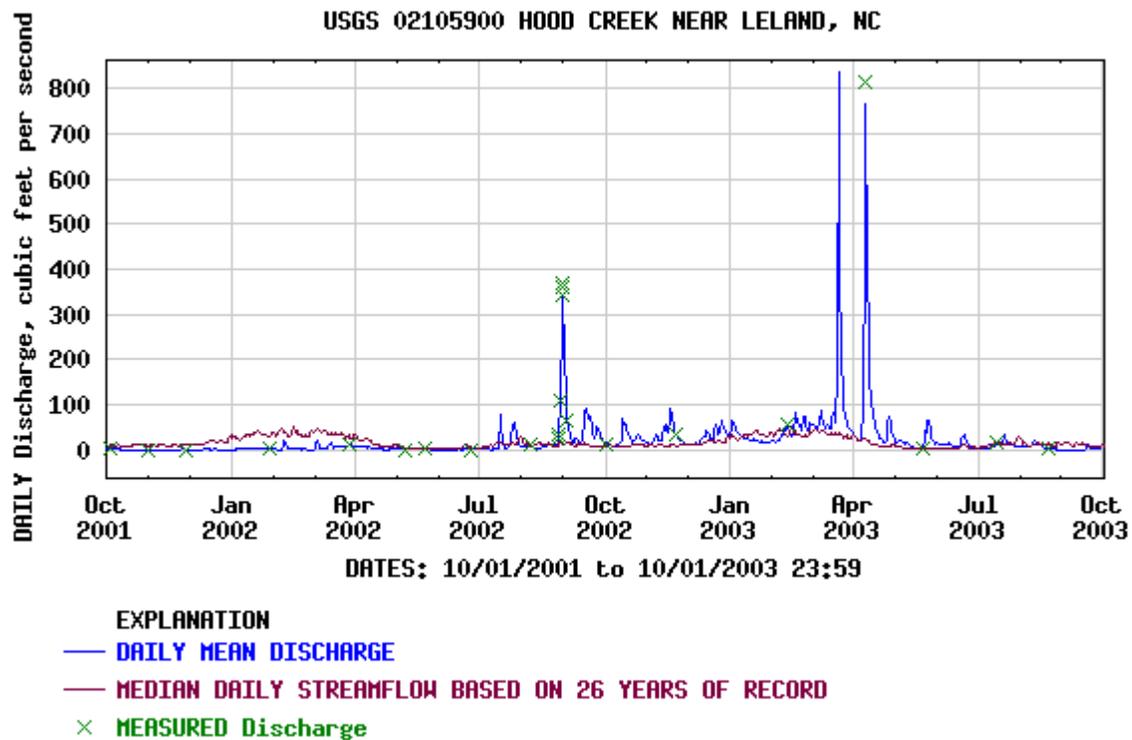
**Figure 2.1 Hydrologic Record of Hood Creek**

No USGS streamflow gage exists on Burnt Mill Creek. The closest one is on Hood Creek near Leland, NC. This is about fifteen miles west-northwest from downtown Wilmington, so Burnt Mill Creek may follow a similar pattern. The biggest unknown in this estimation is the influence of tides from the Cape Fear River. Those are more likely to affect Burnt Mill Creek than Hood Creek, since Burnt Mill Creek is closer to the mouth of the Cape Fear River; however the Hood Creek gage is only 12 feet above m.s.l. As shown in Figure 2.1, from October 2001 to October 2003 Hood Creek experienced a period of below average flow until September 2002. After this time, more rain fell and the flows tended to be above average until July 2003. This is fortuitous for this study because it allows us to observe the stream during a range of conditions, when different causes and sources may be more prevalent.

Note on Figure 2.1: For readers without a color printout, the median daily streamflow based on 22 years of record is the less dynamic line.

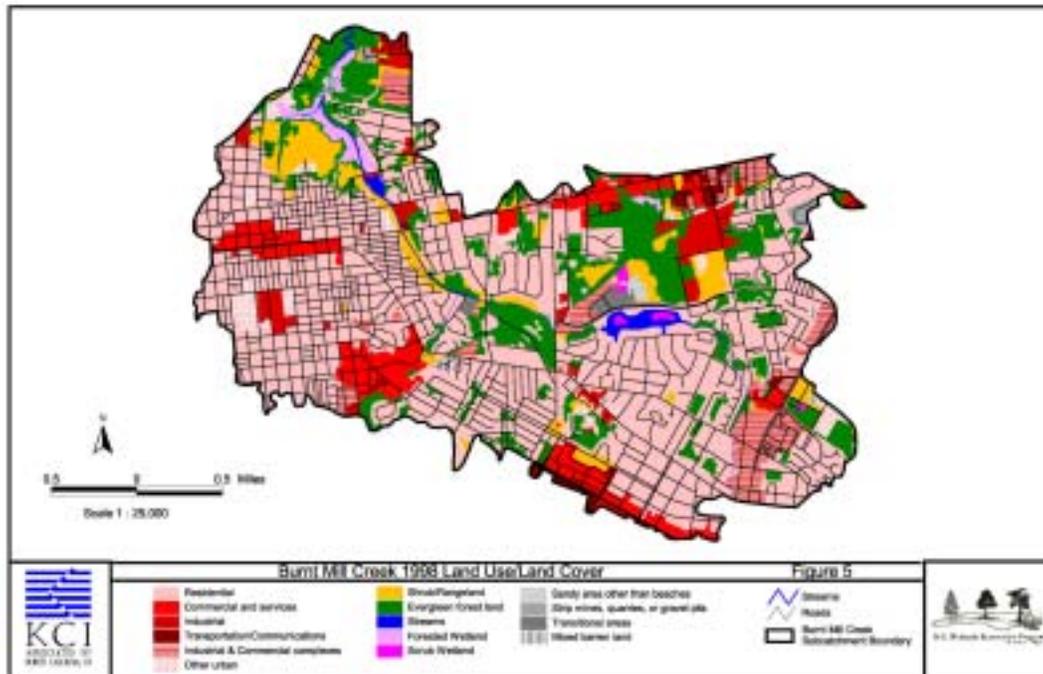
**Figure 2.2 Watershed Land Use**

KCI reports that the Burnt Mill Creek watershed is comprised of 75% urban land uses, and has approximately 64% impervious cover, through which water does not readily infiltrate. This is a very urban system, and impacts from such a developed watershed are expected to be high.

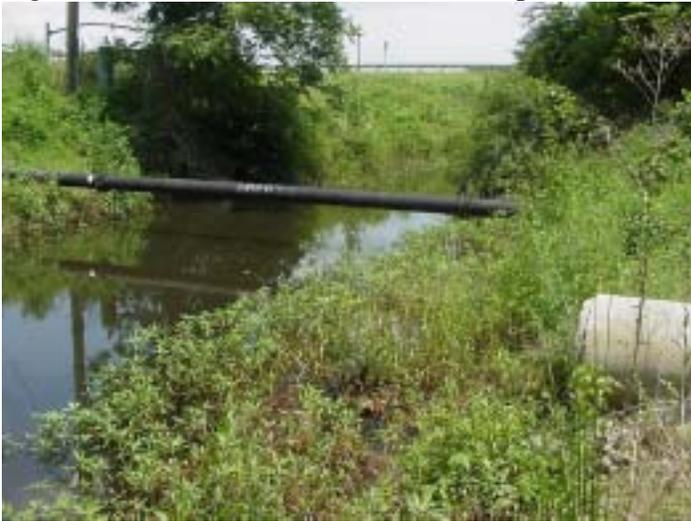
Figure 4.1 Burnt Mill Creek At Independence Dr.

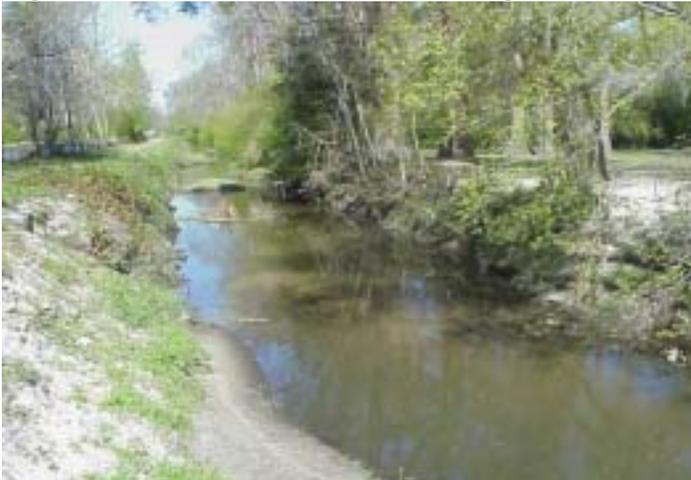
Figure 4.2 Burnt Mill Creek looking downstream from Forest Hills Drive

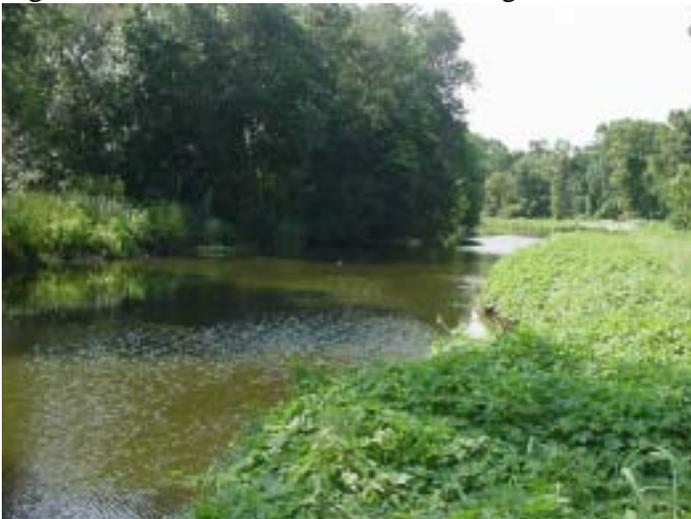
Figure 4.3 Burnt Mill Creek looking downstream from Princess Place

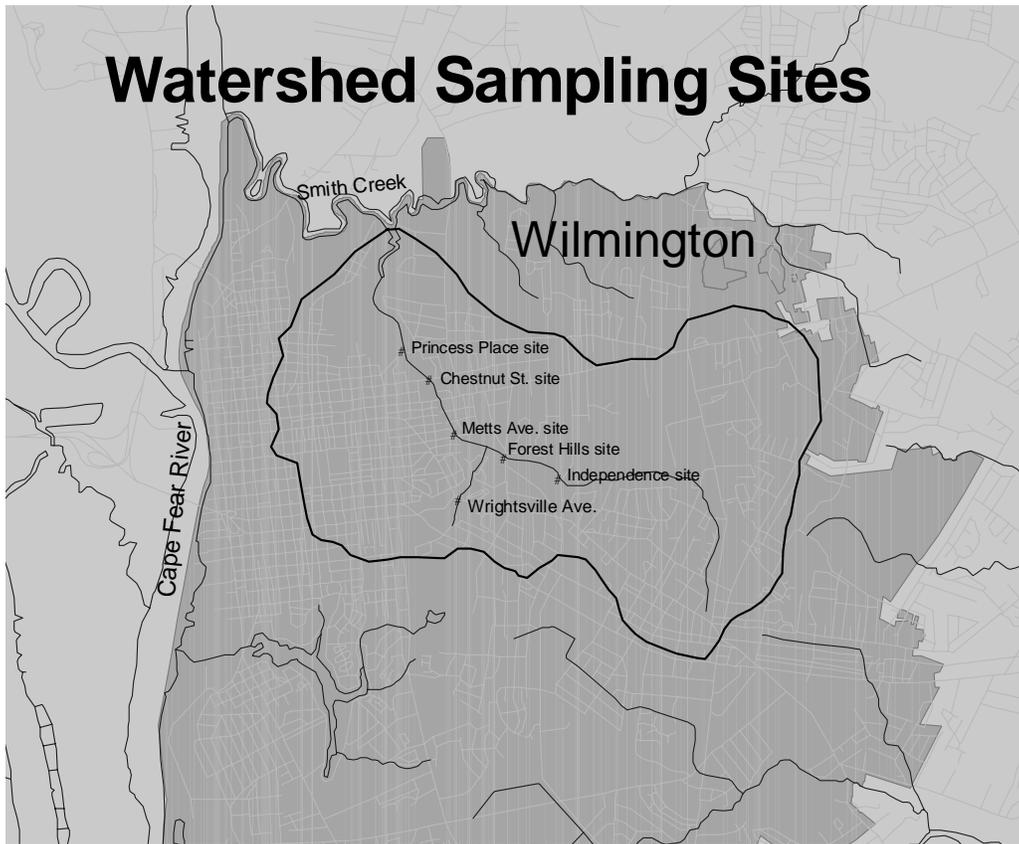
Figure 5.1 Map with locations of chemical sampling stations

- *Burnt Mill Creek at Independence/Mercer.* DWQ analyzed one sediment sample from this site for metals, semi-volatile organics and pesticides. It should show what pollutants exit Ann McCrary Pond, or that originate from the very small area between the pond and this site.
- *Burnt Mill Creek at Princess Place.* DWQ analyzed one sediment sample from this site for metals, semi-volatile organics and pesticides. We also collected a semi-volatile water sample here, as there is a boom in place to trap less dense liquids that come from a stormwater outfall.
- *Mineral Springs Branch below Wrightsville Road.* DWQ analyzed one sediment sample from this site for metals, semi-volatile organics and pesticides.

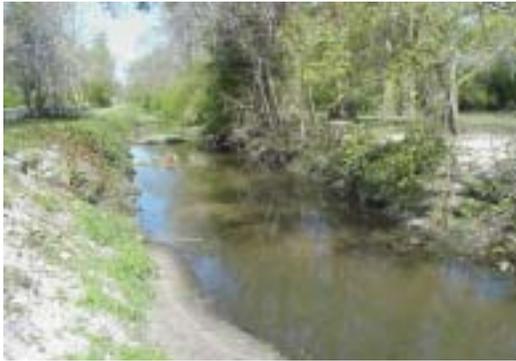
Burnt Mill Creek Forest Hills Drive

**Burnt Mill Creek, Forest Hills Dr., Wilmington, New Hanover County, Cape Fear subbasin 23, 3/28/01.** This site was located one bridge crossing upstream of the previously sampled location at Metts Avenue in Wilmington. Farther upstream was too small to sample, and further downstream of Metts Avenue, there was no visible current, possibly due to tidal influence.
