## Division of Water Quality Biological Assessment Unit

### MEMORANDUM

Subject: Fish community assessments of Catheys and Hollands Creeks (Rutherford County, Broad River Basin, Subbasin 02, Index Nos. 9-41-13-(0.5), 9-41-13-(6), and 9-41-13-7-(3)).

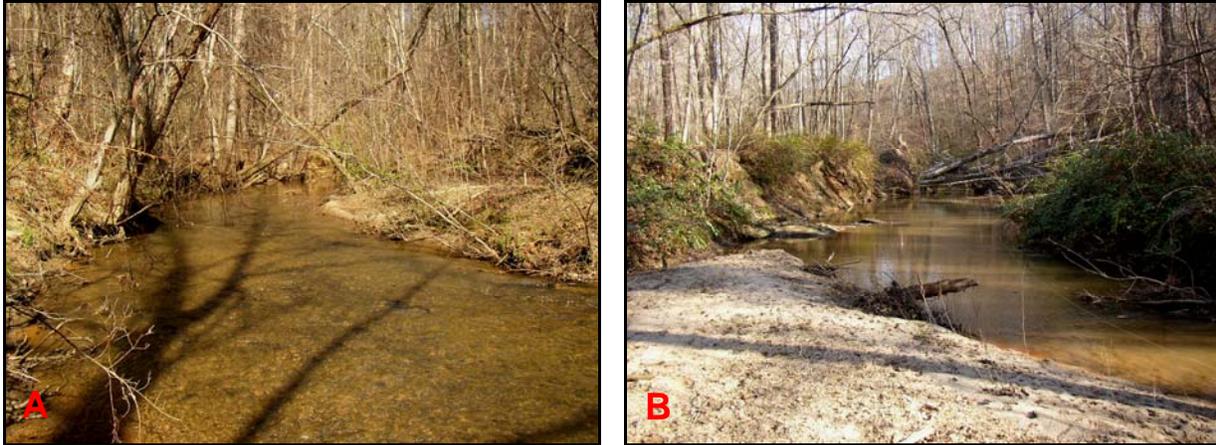
Site No. 1 is located in the upper part of the watershed at US 221, above the stream's confluence with Cherry Creek (Figure 1). Fish were sampled beginning about 50 ft downstream of the concrete culverts (Figure 2). Typically, the upstream section of a stream is sampled, but atypical habitats (i.e. impassible tree snags) prevented this. Visible land use was about 75 percent forest with some recent logging activity, and about 25 percent active pasture. The riparian zone was good and consisted primarily of a beech forest with dog hobble growing along the bank. Instream habitats consisted of runs, snags, and pools created by undercut roots and deadfalls. The major habitat degradations at this site were highly embedded, sandy substrates and a lack of cobble riffle habitats. The overall habitat score for this site was 64 (Table 1).

**Figure 2.** Catheys Creek downstream of US 221 showing the beginning of the sample reach (A) and sand bar formation, dog hobble, and a large beech tree snag near the end of sample reach (B).

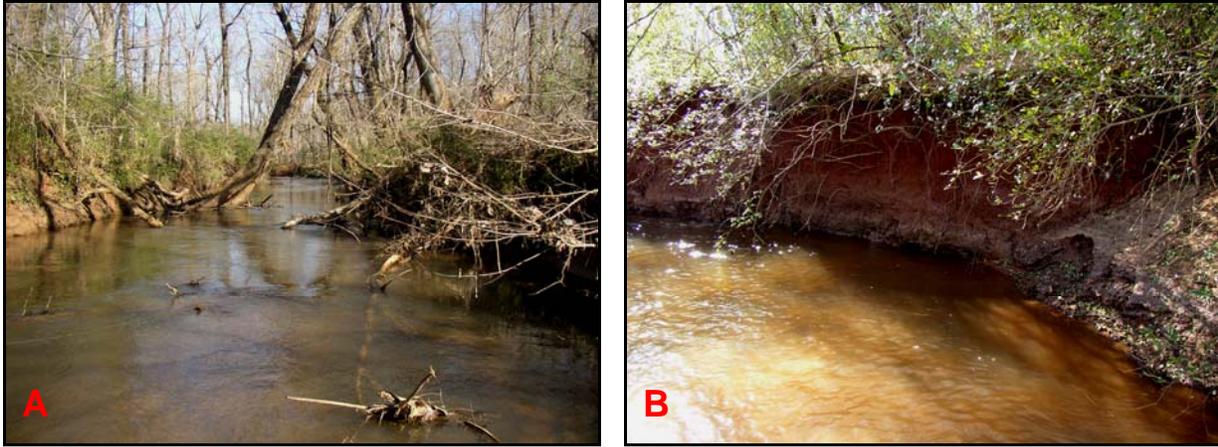
Site No. 2 is located in the lower part of the watershed at SR 1549, about 1.5 miles upstream from its confluence with the Second Broad River (Figure 1). Fish were sampled upstream of the bridge. Visible land use was about 50 percent hayfield/inactive pasture, 30 percent forest, and 20 percent residential. The riparian zone was good along the left bank with no breaks, but poor along the right bank at the upper end of the site where cattle had access to the stream *via* a small tributary. Bank stability was poor along both stream banks and there was evidence of scouring along the left stream bank at a bend near the upper end of the sample reach (Figure 3B). Instream habitats were poor at this site and consisted primarily of runs with some riffles created by stick packs; snag pools; and some large woody debris (Figure 3A). This site had the same habitat problem as Site No. 1, with sand filling the stream channel, poor fish habitats, and almost no functional riffles. The overall habitat score for this site was 41 (Table 1).

**Figure 3. Catheys Creek above SR 1549 showing typical instream habitat types (A) and highly erodible stream bank (B).**

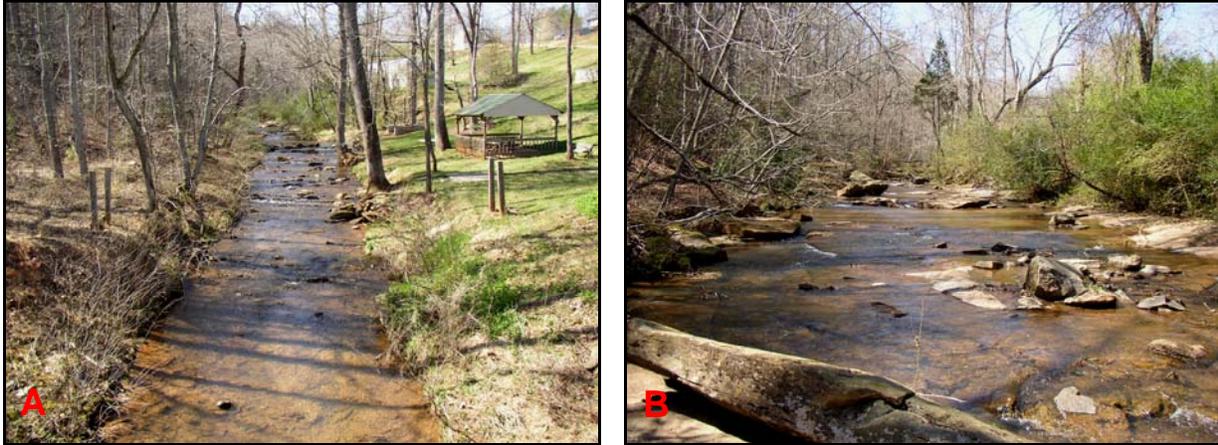
Site No. 3 is located at SR 1547, about 3.5 miles above the stream’s confluence with Catheys Creek (Figure 1). Fish were sampled upstream of the SR 1547 bridge (Figure 4). Visible land use was primarily forest and the riparian zone was good. Although a section of lawn at the lower end of the sample reach provided soil stabilization, this was the major cause of the slight habitat degradation at this site (Figure 4A). Instream habitats were atypical for this portion of the Catheys Creek watershed (Andrea Leslie, pers. comm.) and consisted primarily of bedrock, boulders, and cobble with moderate gradient plunge pools, and rocky runs. The difference in substrate type in this segment of Hollands Creek appeared to reflect the local geology rather than land use changes (NCDENR 2003b). Nutrient inputs were also evident, as slick periphyton covered all instream substrates. The overall habitat score for this site was 82 (Table 1).

**Figure 4. Hollands Creek above SR 1547 showing residential lawn on the right bank just upstream of the bridge (A), bedrock, and rocky runs (B).**

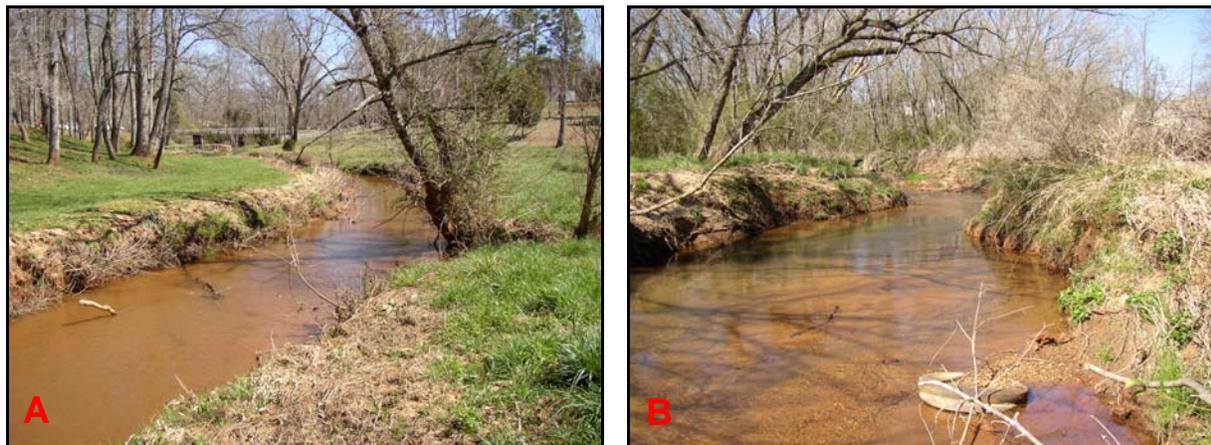
Site No. 4 is located on Hollands Creek at SR 1548, just upstream of the stream’s confluence with Catheys Creek. Fish were sampled upstream from the SR 1548 bridge. The riparian zone at this site was essentially non-existent, consisting primarily of lawns, very little stream cover and very erodible banks (Figure 5). Instream habitats were also extremely poor, and were limited to runs with some side snags created by the few trees present in the sample reach, a few stick riffles, and one plunge pool created by some old concrete slabs used for channel stabilization. The channel was also filled with sand

and silt. Although the water clarity was good, the stream was easily silted during fish sampling. The overall habitat score for this site was 26 (Table 1).

**Figure 5. Hollands Creek above SR 1548 showing lack of riparian zone and siltation from fish sampling (A), and erodible banks (B).**
